# Non-uniform Copper Corrosion: Research Update

AWWARF 2927 Project Meeting,  
Aug. 24, 2004  
Cincinnati, Ohio

# Installation, Condition Assessment, and Reliability of Service Lines, Connections and Fittings AWWARF #2927

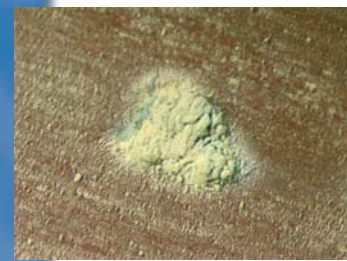
Ohio site #1

# Pitting Comparison

All micrographs taken at 10x

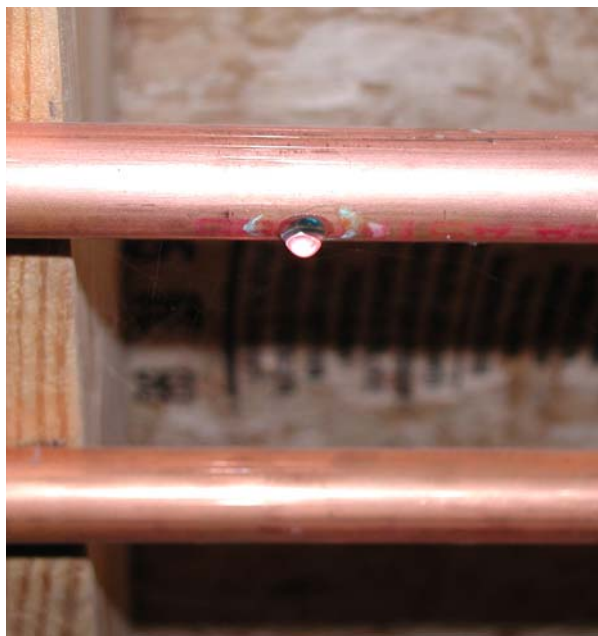
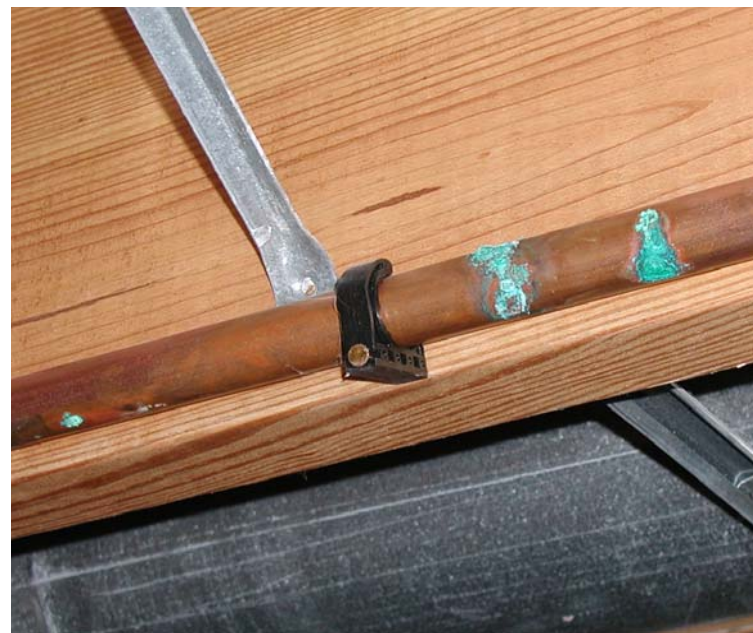
Pinhole leaks resulting from copper pitting

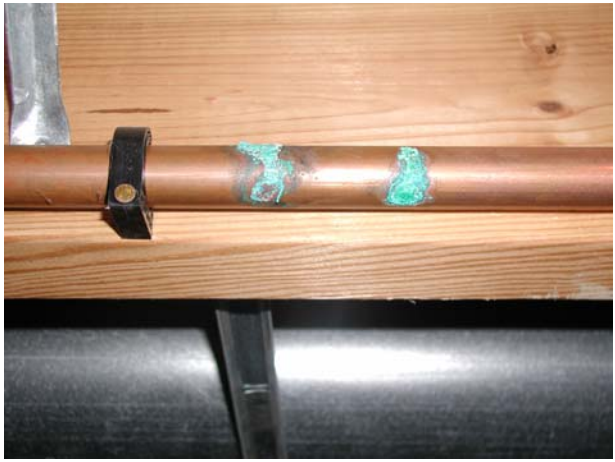
- Cold water
- Horizontal runs of pipe
- $\frac{3}{4}$ " pipe
- Homes are about 7 years old
- Leaks occur near elbows and joints as well as in long runs
- No preference for the top or bottom of a pipe

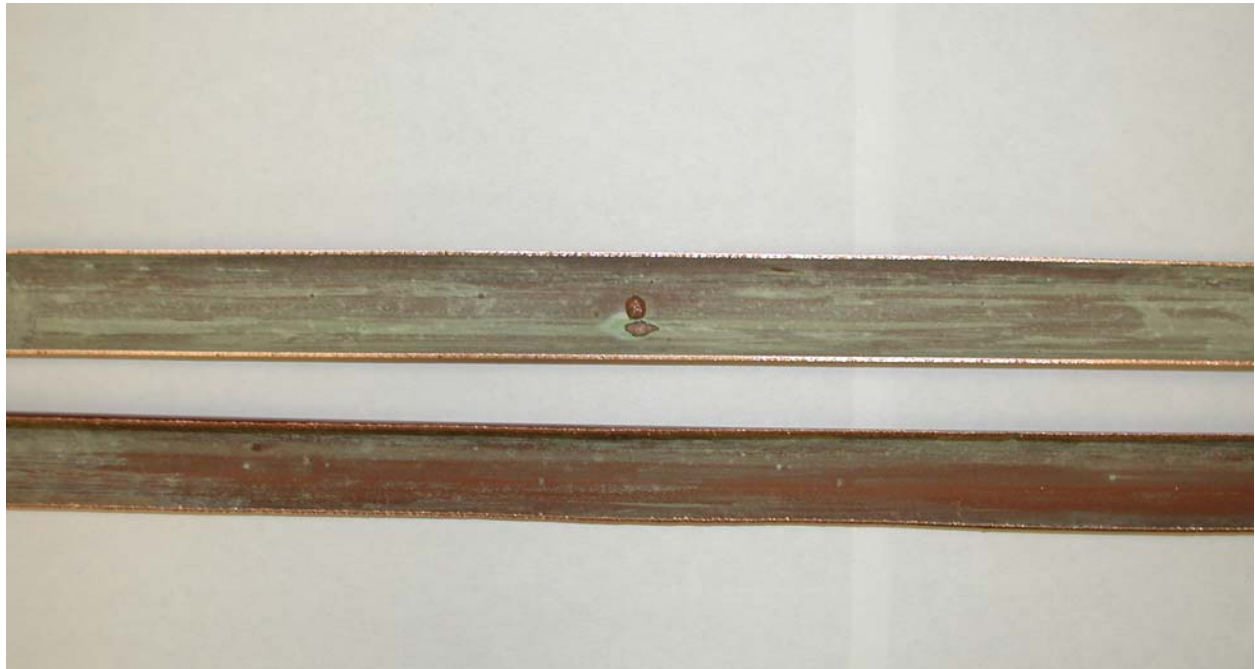
# Pipe Cross-Section Solids Analysis

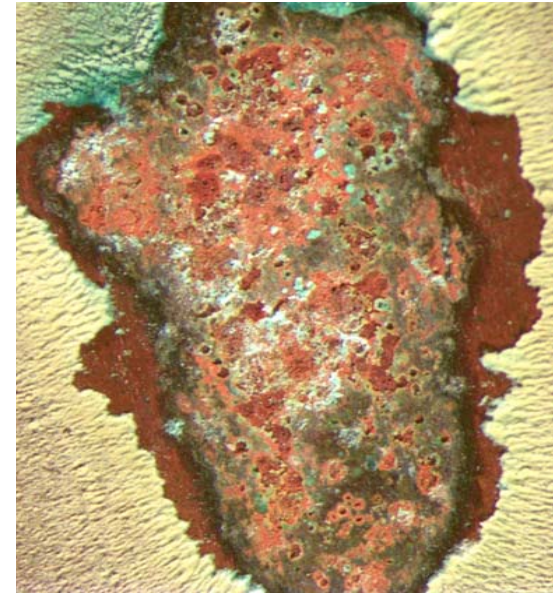
# Perforated Membrane

Literature suggests that the membrane consists of cuprite.

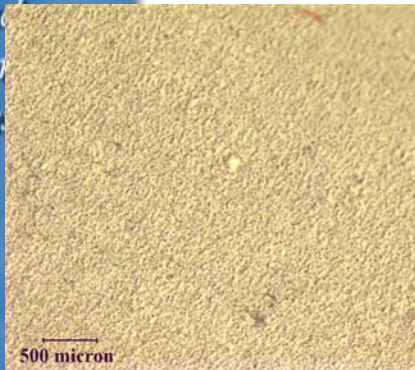
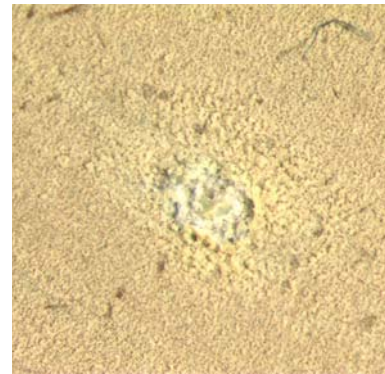
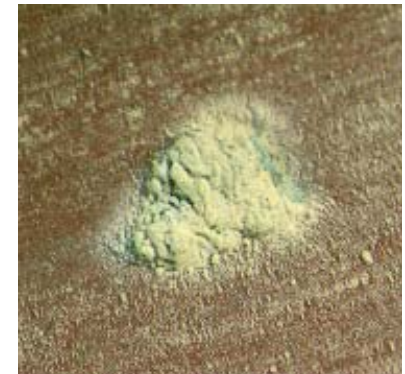
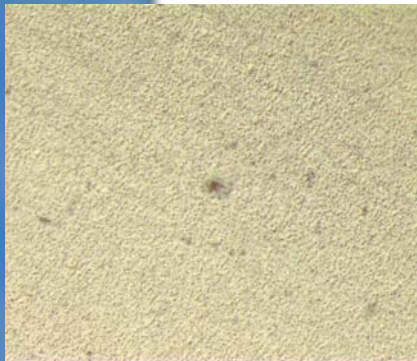
# Pit Propagation Theory

Particle deposition, particle growth, and corrosion cell formation

All pictures taken at same magnification
